**Flood Control Project Maintenance
Levee Inspections**

Maintenance Issue Types Only, Levee Inspection Report By Mile - Fall 2019

Reclamation District No. 2031 Elliot

Waterway	Bank	Unit Miles	Inspection Start/End	Inspector
Unit No. 01 Stanislaus River	Left	7.07	11/20/2019 11/20/2019	Alberto De Leon

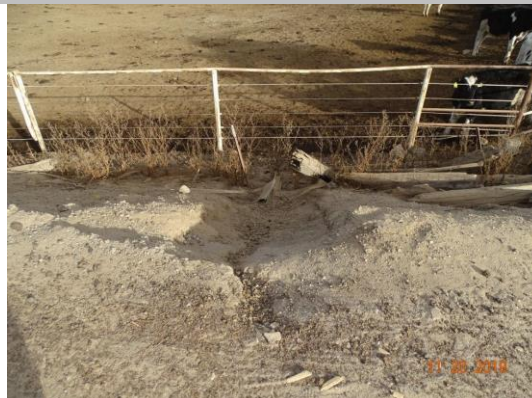
Photo 1 of 2 : FA_2019_RD2031_307_30_20191120_00088.jpg

LM Start	0.02	Rating **	U	Issue No.	30
LM End	0.02	Issue Type +	Ma	Location *	WS
Category	Earthen Levee			GPS Latitude/Longitude	
				Start	End
Item	Erosion / Bank Caving			37.709993 °	37.709993 °
				-121.155771 °	-121.155771 °
DWR ID	DWR_RD2031_01_s_2019_30				
Comment Code					
E2 : Schedule repair of erosion site prior to the next inspection.					
Inspector Comment

View of erosion on waterside slope (approximately 4 ft. wide, 1 ft. deep, 8 ft. long). Fall 2019

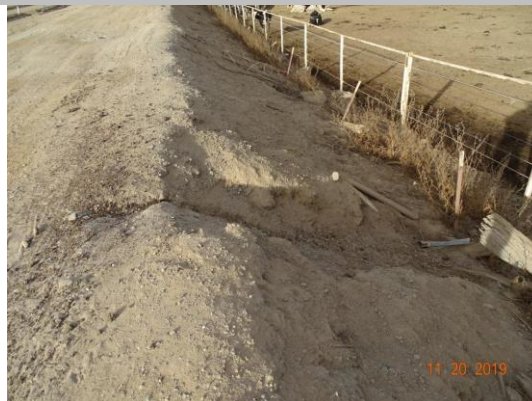
Photo 2 of 2 : FA_2019_RD2031_307_30_20191120_00089.jpg

LM Start	0.02	Rating **	U	Issue No.	30 (cont)
LM End	0.02	Issue Type +	Ma	Location *	WS

View of erosion on waterside slope (approximately 4 ft. wide, 1 ft. deep, 8 ft. long). Fall 2019

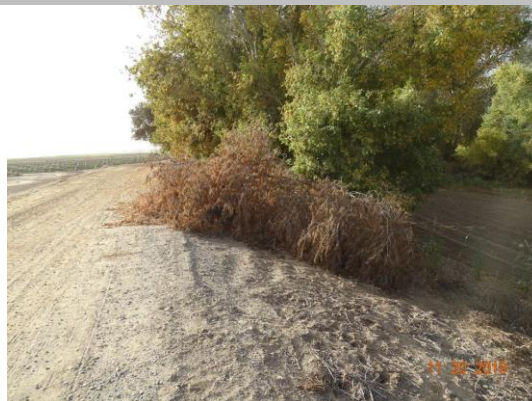
Photo 1 of 1 : FA_2019_RD2031_307_33_20191120_00090.jpg

View of prunings on waterside slope. Fall 2019

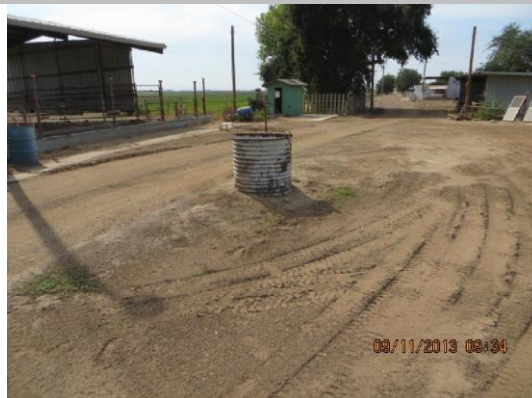
Photo 1 of 3 : UCIP_FA_2019_20044_33942.jpg

LM Start	0.56	Rating **	A/W	Issue No.	974
LM End	0.56	Issue Type +	Ma	Location *	
Category	Supplemental			GPS Latitude/Longitude	
				Start	End
Item	DRAFT DWR UCIP LMA Responsibility			37.703323 °	37.703323 °
				-121.159771 °	-121.159771 °
DWR ID	20439				
Comment Code					
Inspector Comment					
DS_ID:20439					
FS_ID:20044					
EP_NO: N/A					
Repair Type: No Action Needed					
Crossing Status: Found					
UCIP Comments:					
FIELD_STRUCT_DESC: 15-inch corrugated metal drainage pipe through the levee, 9 feet below the crown. Slide gate in a 36-inch corrugated metal pipe (CMP) riser on the waterside (WS) slope. Drainage canal off the landside (LS) toe. This pipe replaced a 15-inch pipe at the same location. [Additional Reference(s): DWR Levee Log, 2005. USACE San Joaquin O&M Manual 4, June 1968, (HLM 0.57)].					
FS Date: 9/11/2013

36-inch CMP riser on WS shoulder.

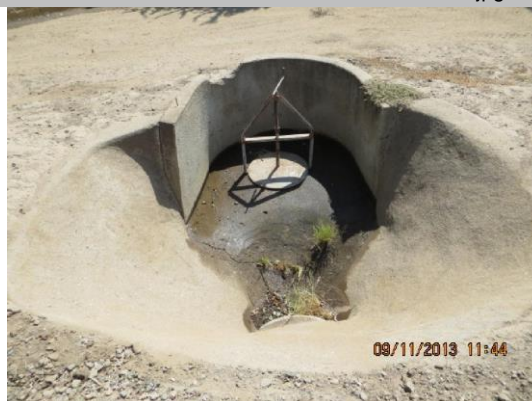
Photo 1 of 3 : UCIP_FA_2019_20088_34030.jpg

LM Start	1.55	Rating **	A/W	Issue No.	980	
LM End	1.55	Issue Type +	Ma	Location *		
Category	Supplemental			GPS Latitude/Longitude		
				Start	End	
Item	DRAFT DWR UCIP LMA Responsibility			37.698921 °	37.698921 °	
				-121.174144 °	-121.174144 °	
DWR ID	20446					
Comment Code						
Inspector Comment						
DS_ID:20446 FS_ID:20088 EP_NO: N/A Repair Type: No Action Needed Crossing Status: Found UCIP Comments: FIELD_STRUCT_DESC: 24-inch corrugated metal drainage pipe through the levee, 3.5 feet below the crown. Concrete headwalls on both ends. Flap gate on the waterside (WS) end. Installed by USACE in 1966. [Additional Reference(s): DWR Levee Log, 2005. USACE San Joaquin O&M Manual 4, June 1968, (HLM 1.56)]. FS Date: 9/11/2013

Bowl shaped concrete inlet on LS slope.

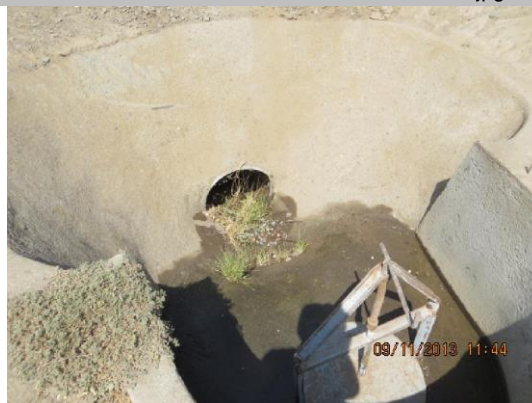
Photo 2 of 3 : UCIP_FA_2019_20088_34029.jpg

Bowl shaped concrete inlet on LS slope.

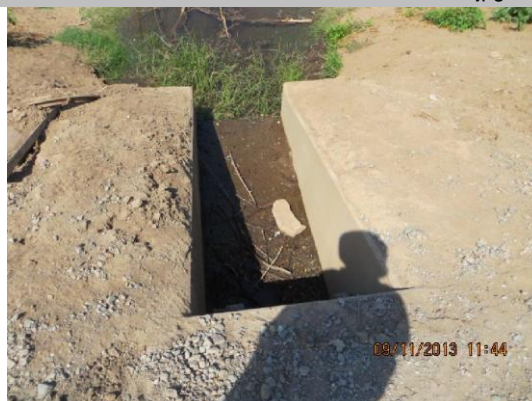
Photo 3 of 3 : UCIP_FA_2019_20088_34028.jpg

Concrete U-shaped headwall on WS slope.

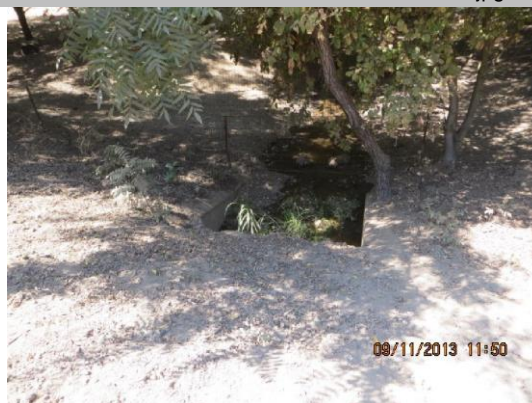
Photo 1 of 3 : UCIP_FA_2019_41354_34034.jpg

LM Start	1.78	Rating **	M	Issue No.	981
LM End	1.78	Issue Type +	Ma	Location *	
Category	Supplemental			GPS Latitude/Longitude	
				Start	End
Item	DRAFT DWR UCIP LMA Responsibility			37.696958 °	37.696958 °
				-121.177464 °	-121.177464 °
DWR ID	20470				
Comment Code					
Inspector Comment					
DS_ID:20470					
FS_ID:41354					
EP_NO: N/A					
Repair Type: Non-Urgent					
Crossing Status: Found					
UCIP Comments: Silt buildup at inlet and outlet.					
FIELD_STRUCT_DESC: 1 of 2: 24-inch corrugated metal drainage pipe through the levee, 9.5 feet below the crown. Concrete U-shaped headwalls on both ends. Flap gate on the waterside (WS) end. Installed by USACE in 1966. [Additional Reference(s): DWR Levee Log, 2005. USACE San Joaquin O&M Manual 4, June 1968, (HLM 1.80)].					
FS Date: 9/11/2013

Concrete headwall on WS toe.

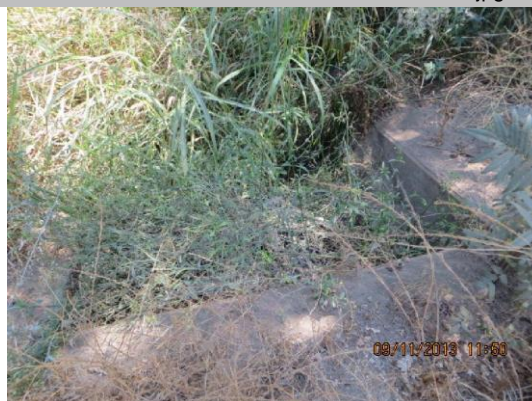
Photo 2 of 3 : UCIP_FA_2019_41354_34033.jpg

Concrete headwall on LS toe.

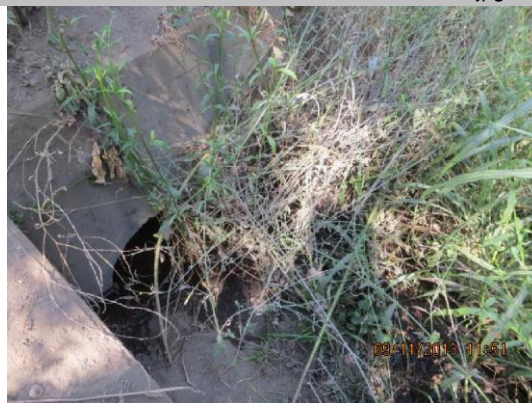
Photo 3 of 3 : UCIP_FA_2019_41354_34032.jpg

Concrete headwall at LS toe.

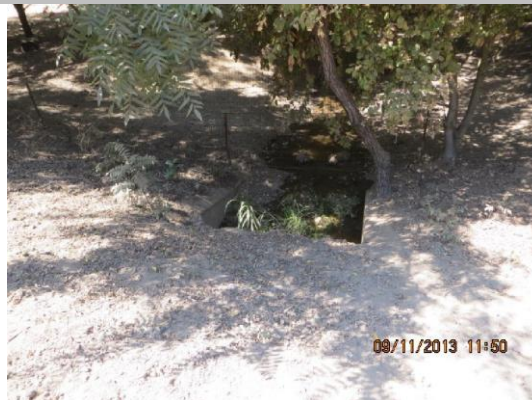
Photo 1 of 3 : UCIP_FA_2019_20092_34041.jpg

LM Start	1.78	Rating **	M	Issue No.	982
LM End	1.78	Issue Type +	Ma	Location *	
Category	Supplemental			GPS Latitude/Longitude	
				Start	End
Item	DRAFT DWR UCIP LMA Responsibility			37.696943 °	37.696943 °
				-121.177470 °	-121.177470 °
DWR ID	20447				
Comment Code					
Inspector Comment					
DS_ID:20447 FS_ID:20092 EP_NO: N/A Repair Type: Non-Urgent Crossing Status: Found UCIP Comments: Silt buildup at inlet and outlet. FIELD_STRUCT_DESC: 2 of 2: 24-inch corrugated metal drainage pipe through the levee, 9.5 feet below the crown. Concrete U-shaped headwalls on both ends. Flap gate on the waterside (WS) end. Installed by USACE in 1966. [Additional Reference(s): DWR Levee Log, 2005. USACE San Joaquin O&M Manual 4, June 1968, (HLM 1.80)]. FS Date: 9/11/2013

Concrete U-shaped headwall on WS toe.

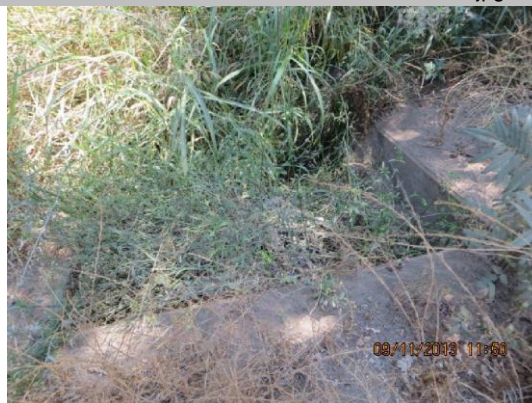
Photo 2 of 3 : UCIP_FA_2019_20092_34040.jpg

Concrete U-shaped headwall on LS toe.

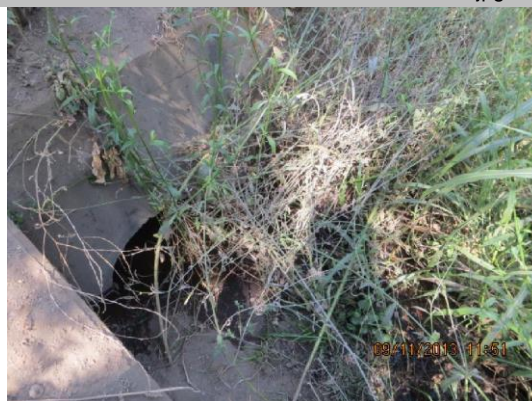
Photo 3 of 3 : UCIP_FA_2019_20092_34039.jpg

Concrete U-shaped headwall on LS toe.

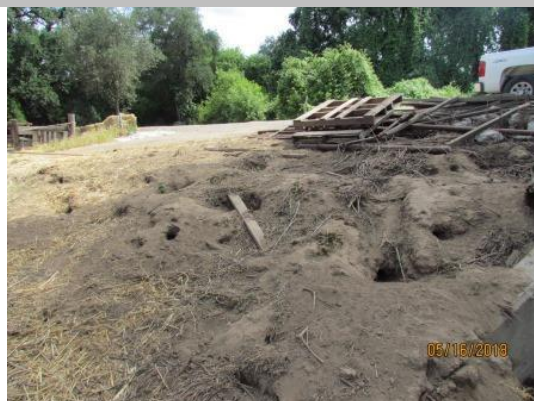
Photo 1 of 1 : FA_2019_RD2031_307_49_20190830_00014.jpg

View of the waterside where several squirrel holes are and active rodent activity.

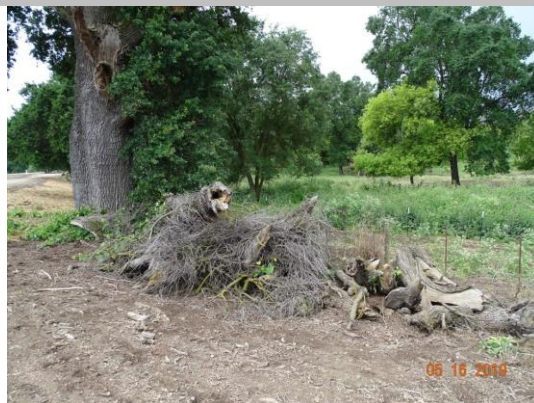
Photo 1 of 1 : FA_2019_RD2031_307_42_20190830_00011.jpg

LM Start	2.06	Rating **	U	Issue No.	42
LM End	2.06	Issue Type +	Ma	Location *	WS
Category	Earthen Levee			GPS Latitude/Longitude	
				Start	End
Item	Encroachments			37.692896 °	37.692896 °
				-121.177506 °	-121.177506 °
DWR ID	DWR_RD2031_01_s_2019_42				
Comment Code					
PR : Prunings					
Inspector Comment

View of prunings on waterside slope. (Spring 2019)

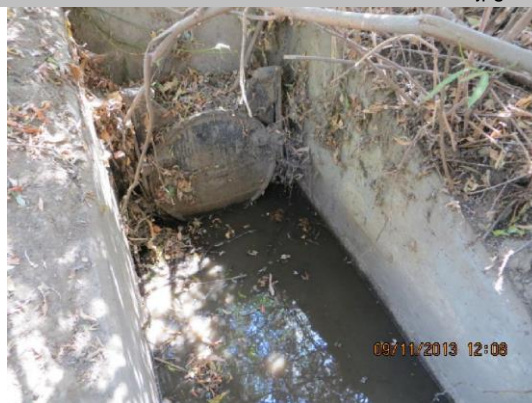
Photo 1 of 3 : UCIP_FA_2019_20110_34078.jpg

LM Start	2.39	Rating **	A/W	Issue No.	984
LM End	2.39	Issue Type +	Ma	Location *	
Category	Supplemental			GPS Latitude/Longitude	
				Start	End
Item	DRAFT DWR UCIP LMA Responsibility			37.688676 °	37.688676 °
				-121.179622 °	-121.179622 °
DWR ID	20449				
Comment Code					
Inspector Comment					
DS_ID:20449 FS_ID:20110 EP_NO: N/A Repair Type: No Action Needed Crossing Status: Found UCIP Comments: FIELD_STRUCT_DESC: 24-inch corrugated metal drainage pipe through the levee, 3 feet below the crown. Concrete U-shaped headwall on the waterside (WS) end. Flap gate on the WS end. 5-foot by 5-foot concrete riser with pump on the LS toe. Likely that concrete riser is inlet for drainage pipe. [Additional Reference(s): DWR Levee Log, 2005. USACE San Joaquin O&M Manual 4, June 1968, (HLM 2.41)]. FS Date: 9/11/2013

Flapgate and concrete headwall on WS toe.

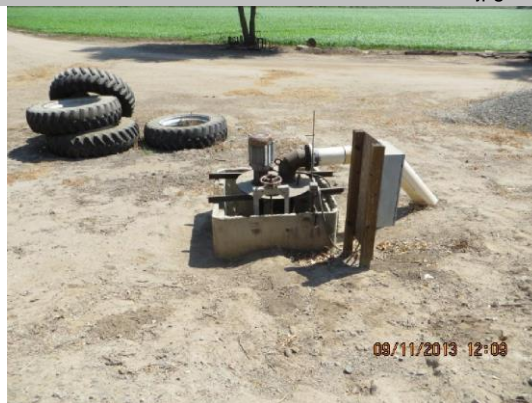
Photo 3 of 3 : UCIP_FA_2019_20110_34076.jpg

5'X5' concrete riser with pump on LS toe.

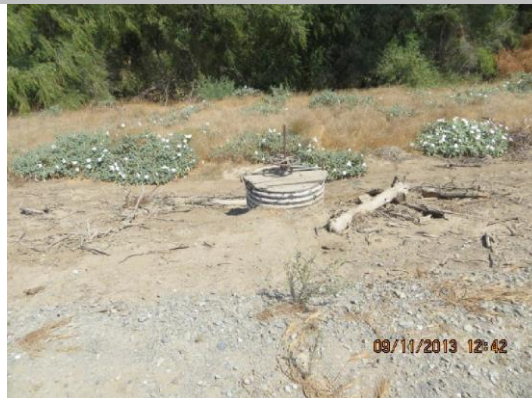
Photo 1 of 3 : UCIP_FA_2019_20449_34506.jpg

LM Start	3.08	Rating **	M	Issue No.	986
LM End	3.08	Issue Type +	Ma	Location *	
Category	Supplemental			GPS Latitude/Longitude	
				Start	End
Item	DRAFT DWR UCIP LMA Responsibility			37.688297°	37.688297°
				-121.190865°	-121.190865°
DWR ID	20451				
Comment Code					
Inspector Comment					
DS_ID:20451 FS_ID:20449 EP_NO: N/A Repair Type: Non-Urgent Crossing Status: Found UCIP Comments: Pipe appears to be abandoned and if so should be done so properly. FIELD_STRUCT_DESC: *ABANDONED* 24-inch corrugated metal drainage pipe through the levee, 14 feet below the crown. Slide gate in a 36-inch corrugated metal pipe (CMP) riser on the waterside (WS) slope. [Additional Reference(s): DWR Levee Log, 2005. USACE San Joaquin O&M Manual 4, June 1968, (HLM 3.11)]. FS Date: 9/11/2013

Slide gate in CMP riser on WS slope.

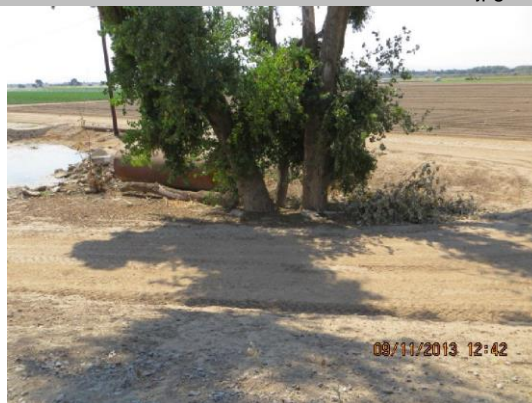
Photo 2 of 3 : UCIP_FA_2019_20449_34505.jpg

Pipe not visible on LS toe.

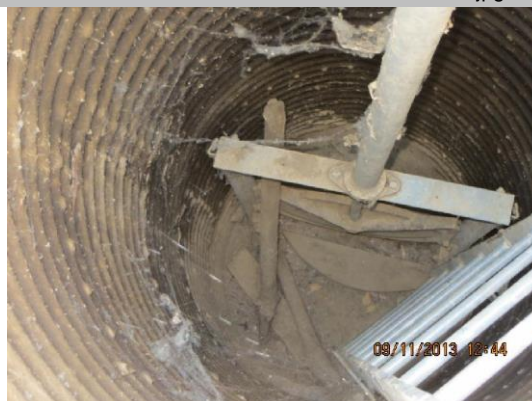
Photo 3 of 3 : UCIP_FA_2019_20449_34504.jpg

Slide gate in CMP riser on WS slope.

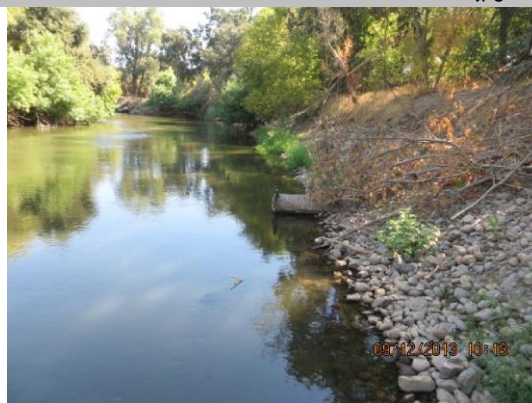
Photo 1 of 2 : UCIP_FA_2019_23064_39200.jpg

LM Start	3.66	Rating **	M	Issue No.	987	
LM End	3.66	Issue Type +	Ma	Location *		
Category	Supplemental			GPS Latitude/Longitude		
				Start	End	
Item	DRAFT DWR UCIP LMA Responsibility			37.689900 °	37.689900 °	
				-121.198319 °	-121.198319 °	
DWR ID	20478					
Comment Code						
Inspector Comment						
DS_ID:20478						
FS_ID:23064						
EP_NO: N/A						
Repair Type: Non-Urgent						
Crossing Status: Found						
UCIP Comments: Good candidate for video inspection.						
FIELD_STRUCT_DESC: 24-inch corrugated metal drainage pipe through the levee, 5.5 feet below the crown. Flap gate visible at the waterside (WS) toe. [Additional Reference(s): USACE San Joaquin O&M Manual 4, June 1968, (HLM 3.7), listed as a 20-inch pipe, 3.9 feet below the crown].						
FS Date: 9/12/2013

CMP pipe and flapgate visible at WS toe.

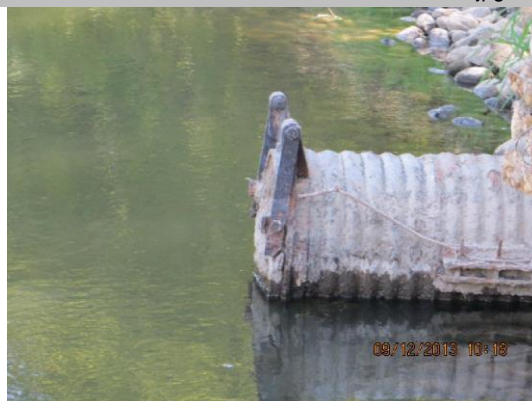
Photo 2 of 2 : UCIP_FA_2019_23064_39199.jpg

CMP pipe and flapgate visible at WS toe.

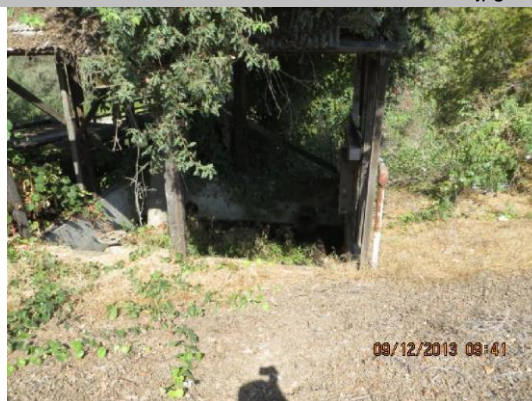
Photo 1 of 3 : UCIP_FA_2019_20683_34782.jpg

Pipe visible inside pumphouse on WS slope.

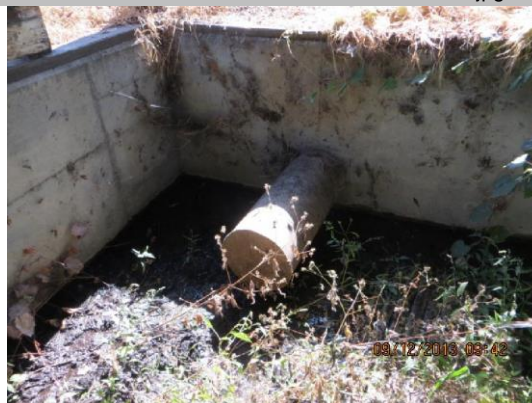
Photo 2 of 3 : UCIP_FA_2019_20683_34781.jpg

Welded steel plate over WS end of pipe.

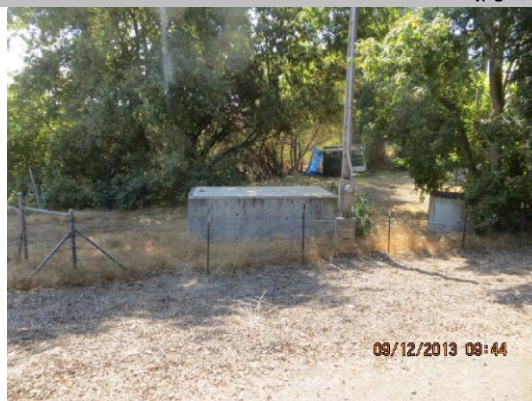
Photo 3 of 3 : UCIP_FA_2019_20683_34780.jpg

Concrete distribution box on LS toe.

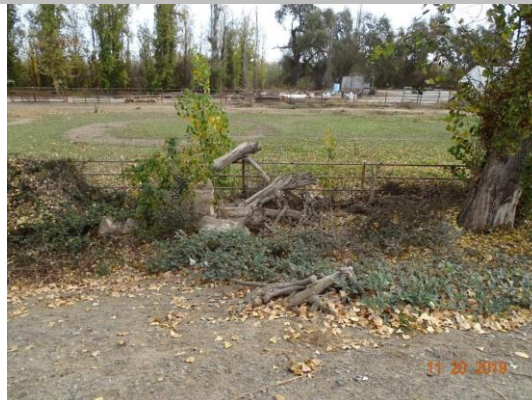
Photo 1 of 1 : FA_2019_RD2031_307_67_20191120_00094.jpg

LM Start	4.50	Rating **	M	Issue No.	67
LM End	4.50	Issue Type +	Ma	Location *	LS
Category	Earthen Levee			GPS Latitude/Longitude	
				Start	End
Item	Encroachments			37.685220 °	37.685220 °
				-121.208386 °	-121.208386 °
DWR ID	DWR_RD2031_01_f_2019_67				
Comment Code					
PR : Prunings					
Inspector Comment

View of prunings on landside slope. Fall 2019

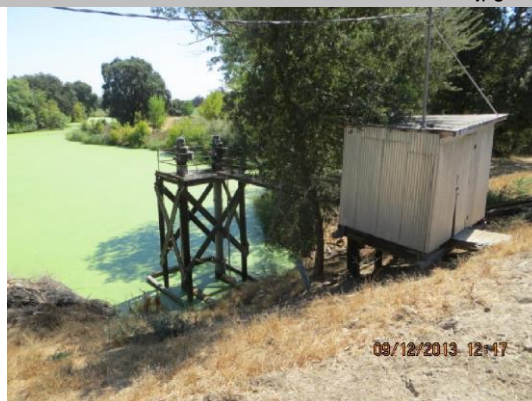
Photo 1 of 3 : UCIP_FA_2019_20703_34822.jpg

Pump on platform at LS toe.

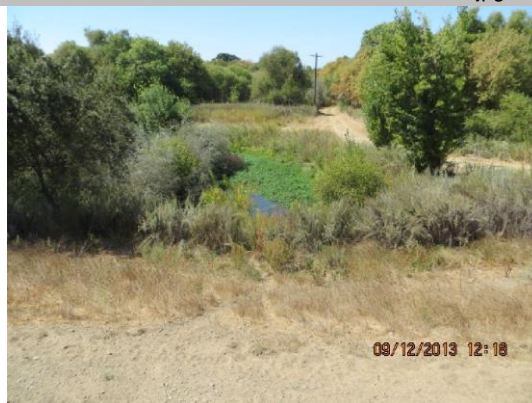
Photo 2 of 3 : UCIP_FA_2019_20703_34821.jpg

Pond at outlet on WS toe.

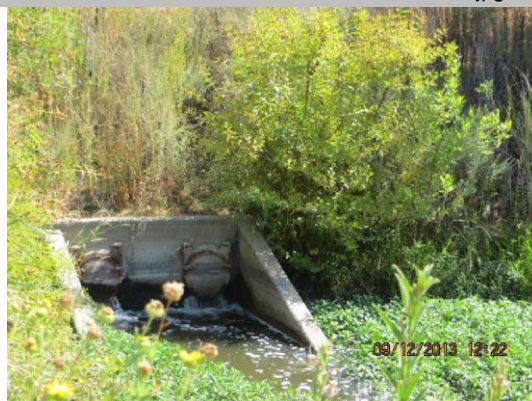
Photo 3 of 3 : UCIP_FA_2019_20703_34820.jpg

Concrete U-shaped headwall with flapgate on WS toe.

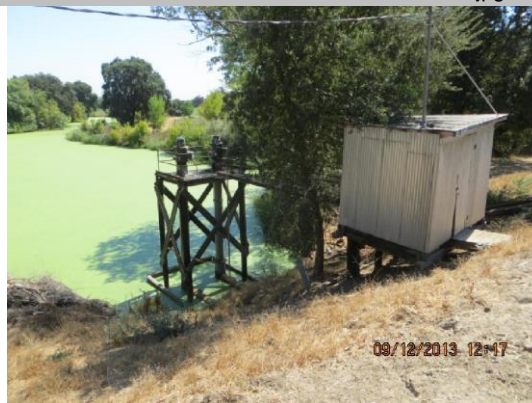
Photo 1 of 3 : UCIP_FA_2019_20704_34826.jpg

LM Start	0.22	Rating **	A/W	Issue No.	968
LM End	0.22	Issue Type +	Ma	Location *	
Category	Supplemental			GPS Latitude/Longitude	
				Start	End
Item	DRAFT DWR UCIP LMA Responsibility			37.658875 °	37.658875 °
				-121.234280 °	-121.234280 °
DWR ID	20508				
Comment Code					
Inspector Comment					
DS_ID:20508 FS_ID:20704 EP_NO: N/A Repair Type: No Action Needed Crossing Status: Found UCIP Comments: FIELD_STRUCT_DESC: 2 of 2: 24-inch steel drainage pipe through the levee, 3.6 feet below the crown. Concrete U-shaped headwall on the waterside (WS) end, and a concrete headwall at the landside (LS) toe. Flap gate on the WS end. Pump on pile structure on the LS. [Additional Reference(s): DWR Levee Log, 2005. USACE San Joaquin O&M Manual 4, June 1968, (HLM 0.24)]. FS Date: 9/12/2013

Pump on pier on LS toe with shed at pump walkway.

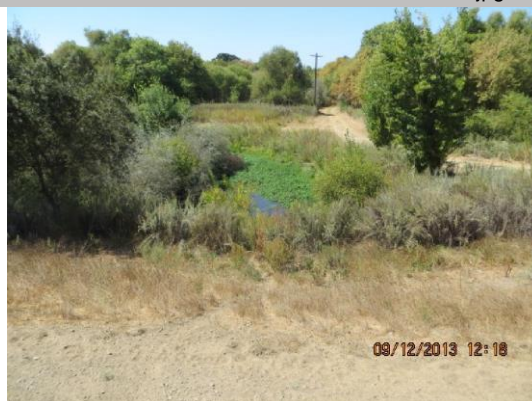
Photo 2 of 3 : UCIP_FA_2019_20704_34825.jpg

Pond at outlet on WS toe.

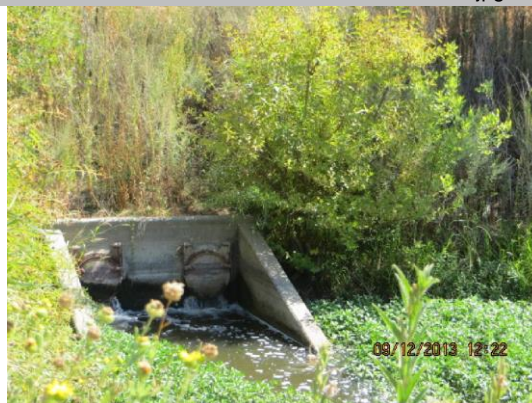
Photo 3 of 3 : UCIP_FA_2019_20704_34824.jpg

Flap gate at Concrete outlet on WS toe.

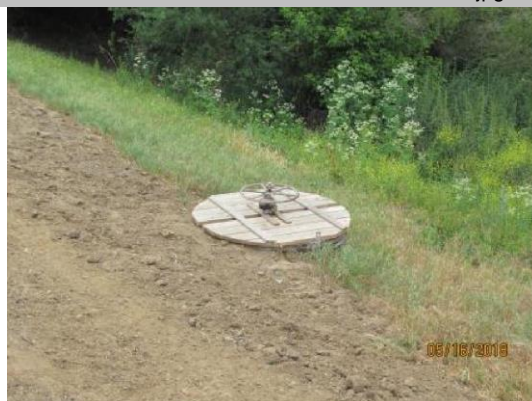
Photo 1 of 3 : UCIP_FA_2019_53836_77560.jpg

5/17/2018- Newly installed lid.

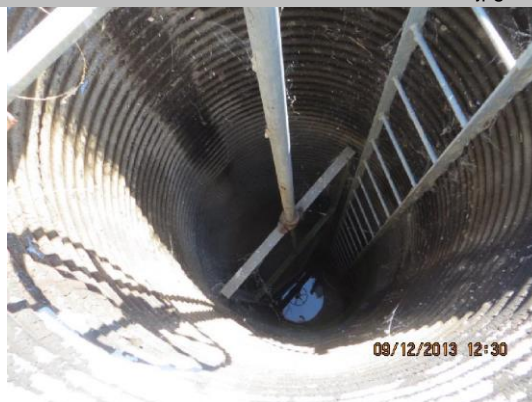
Photo 2 of 3 : UCIP_FA_2019_53836_34834.jpg

Slide gate in CMP riser on WS slope.

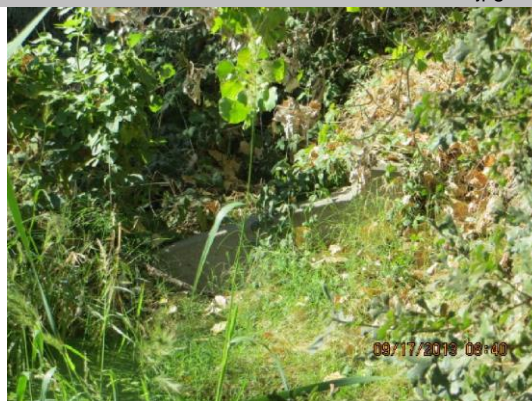
Photo 3 of 3 : UCIP_FA_2019_53836_34833.jpg

Concrete headwall on LS toe at edge of pond.

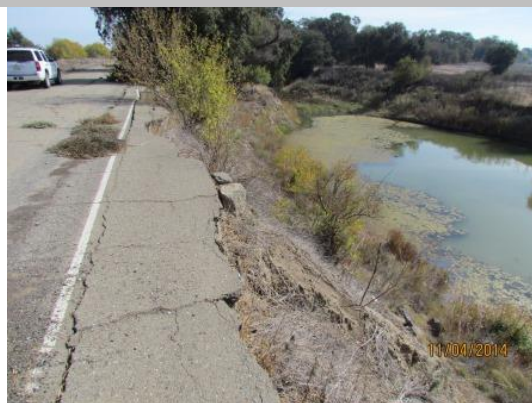
Photo 1 of 1 : FA_2019_RD2031_308_26_20190830_00007.jpg

View of the caving bank on the waterside facing upstream.

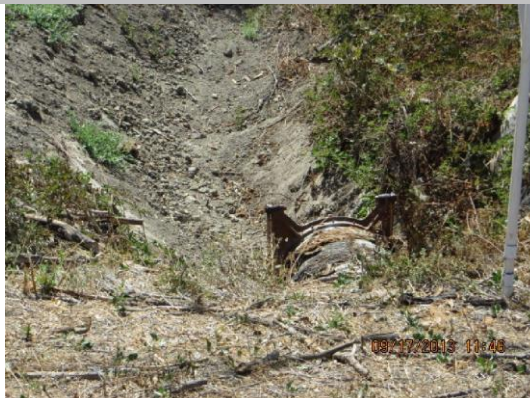
Photo 1 of 3 : UCIP_FA_2019_20723_34882.jpg

Flap gate on CMP pipe at WS toe.

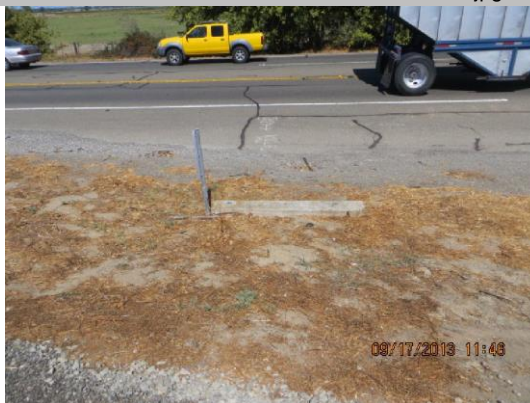
Photo 2 of 3 : UCIP_FA_2019_20723_34881.jpg

Concrete headwall on LS toe.

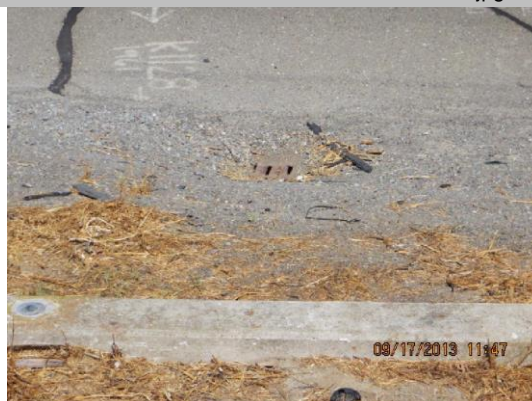
Photo 3 of 3 : UCIP_FA_2019_20723_34880.jpg

Drop inlet on LS toe.

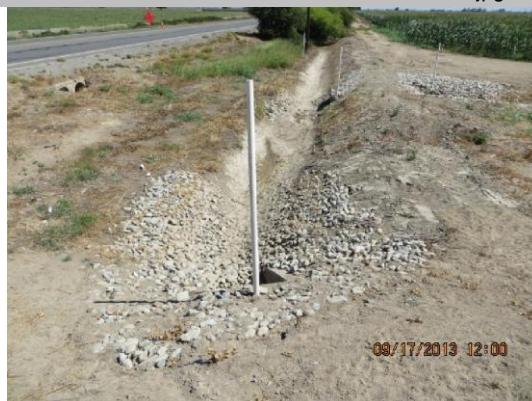
Photo 1 of 3 : UCIP_FA_2019_51374_34886.jpg

Concrete headwall on LS toe.

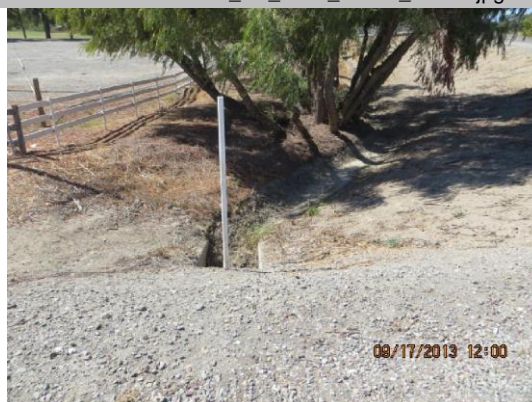
Photo 2 of 3 : UCIP_FA_2019_51374_34885.jpg

Concrete headwall on WS toe.

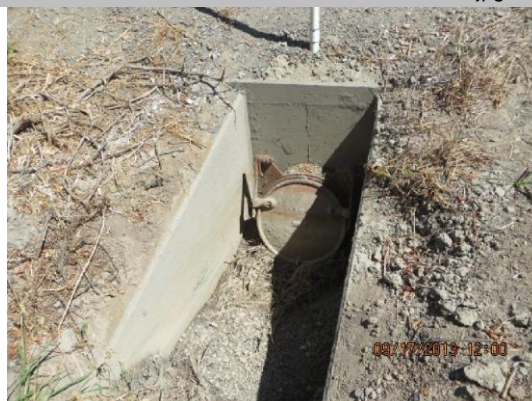
Photo 3 of 3 : UCIP_FA_2019_51374_34884.jpg

Flapgate on WS toe.

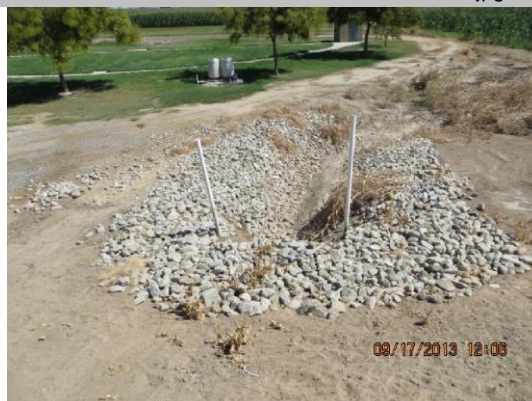
Photo 1 of 3 : UCIP_FA_2019_20728_34895.jpg

Concrete headwall at ditch on LS toe.

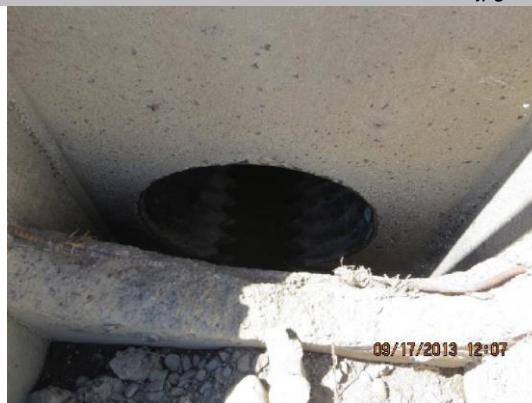
Photo 2 of 3 : UCIP_FA_2019_20728_34894.jpg

Concrete headwall on LS toe.

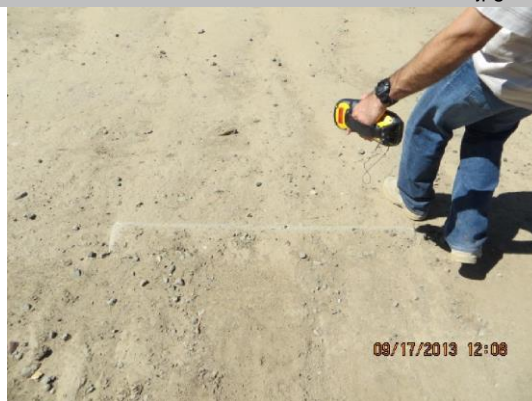
Photo 3 of 3 : UCIP_FA_2019_20728_34893.jpg

Headwall on WS toe.

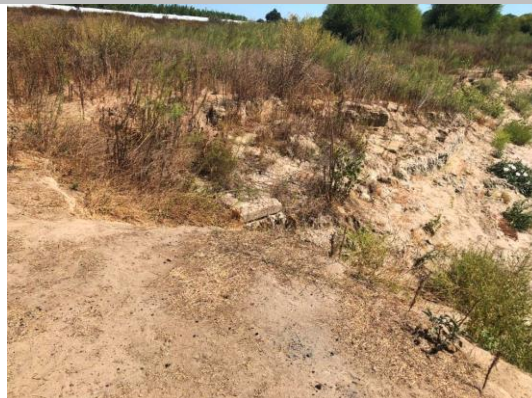
Photo 3 of 3 : SJR2019_RD2031U02RM78.7_2.jpg

Close-up view of the pocket erosion.
